Manhole Inspection Summary

Manhole # S37A1_002MH

Insp Date: **12/8/08 12:54 PM**

Location Address: **e cromwell st**

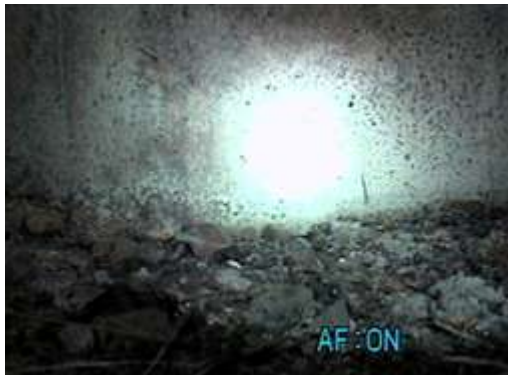
Miscellaneous

bench debris

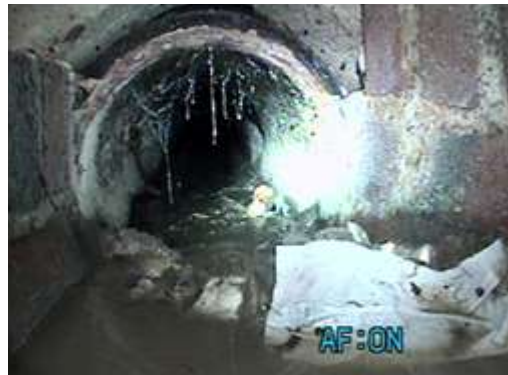
Defect 2

Condition: ☐ Sound ☐ Cracked ☐ Root Intrusion ☐ Deteriorated ☐ Leaks ☒ **Debris**

channel debris

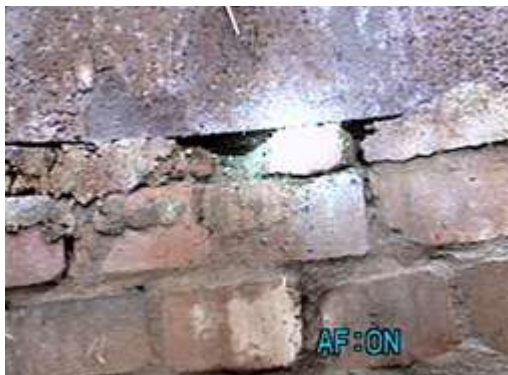
Defect 1

Condition: ☐ Sound ☐ Cracked ☐ Root Intrusion ☒ **Loose Brick** ☐ Deteriorated

chimney loose bricks

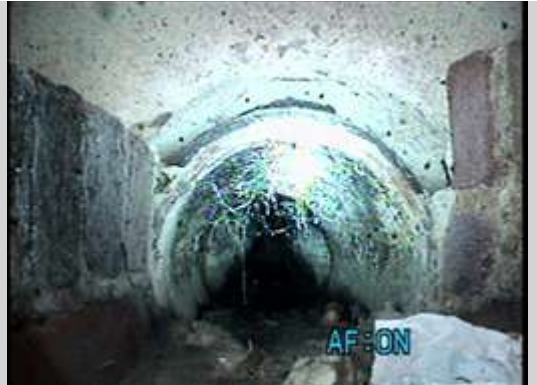
12 O'Clock Outflow

8 in. Circular Gravity Sewer
Pipe Out @ 12 O'Clock

Invert Depth: **10.33** (ft.) Flow Characteristics: **Slow**

Infiltration: **None** Pipe Seal Cond: **Unknown**

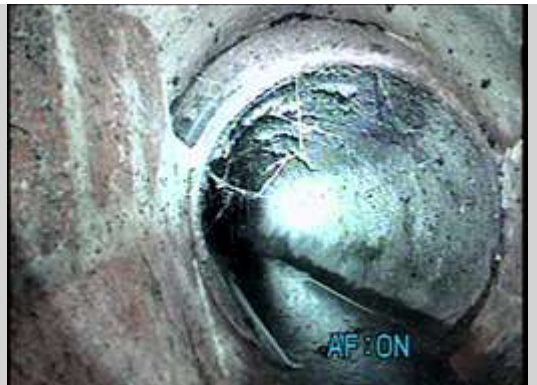
3 O'Clock Inflow

8 in. Circular Gravity Sewer
Pipe In @ 3 O'Clock

Invert Depth: **10.16** (ft.) Flow Characteristics: **None**

Infiltration: **None** Pipe Seal Cond: **Unknown**

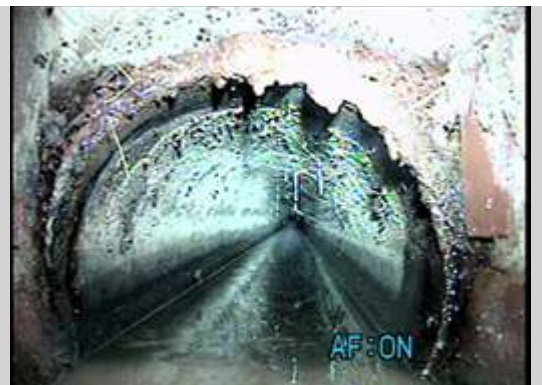
6 O'Clock Inflow

8 in. Circular Gravity Sewer
Pipe In @ 6 O'Clock

Invert Depth: **10.26** (ft.) Flow Characteristics: **Slow**

Infiltration: **None** Pipe Seal Cond: **Unknown**
